Minerals Inspection Report

Mine Name: Lake Point Quarry	Permit Number: M/49/0076	Mine Status: Inactive
Operator Name: Ames Construction	Inspection Date: 02/27/2014	Permit Fees: 500
Inspector(s): A. Abate	Inspection Time: 10:30 AM	Bond Amount: \$172,905
Attendee(s): C. Ennis, L. Botellio	Weather: Rain	Bond Escalation: 7/27/2015
Inspection Purpose: Routine Site Visit		Prior Inspection:

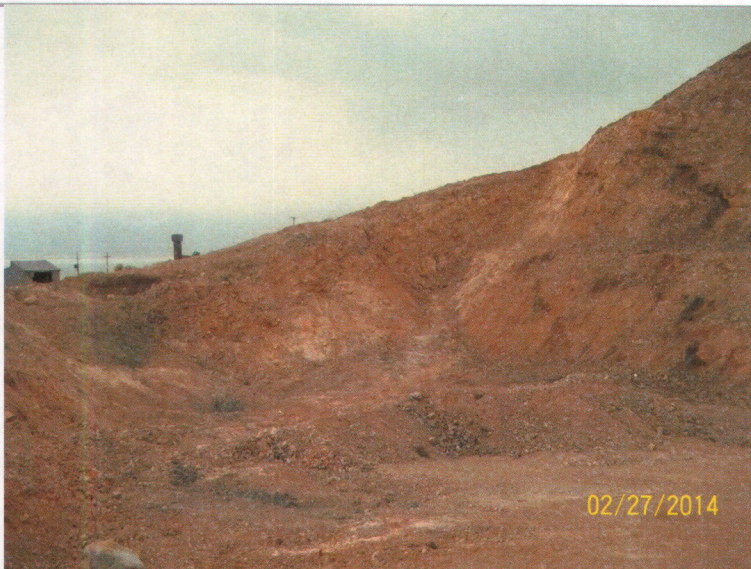
View looking south into the mine pit area.

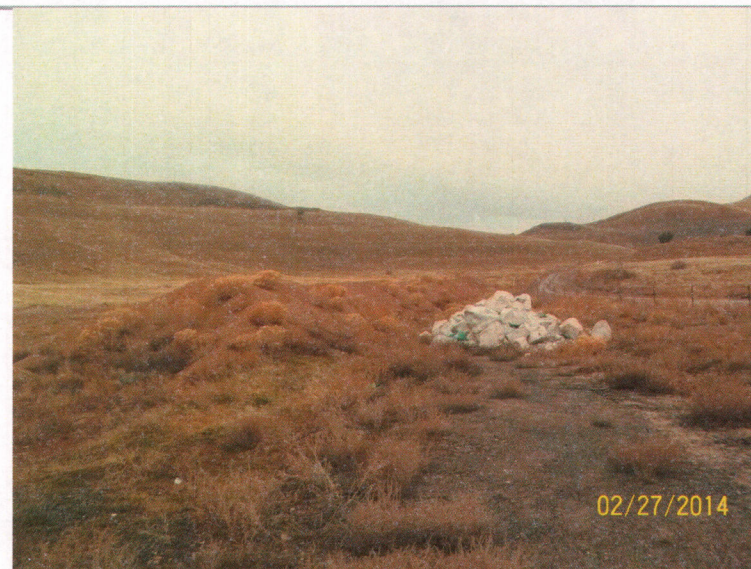
Berm alongside the road on the northern end of the permit area.

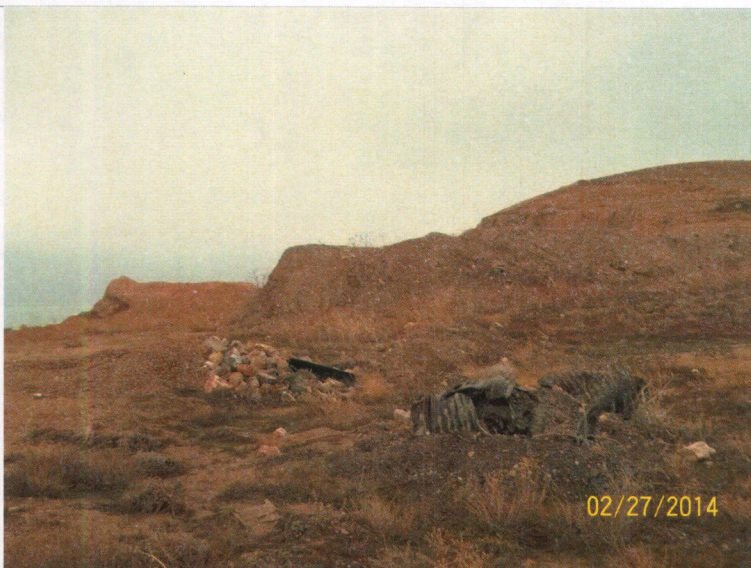
8.	Soils	<input checked="" type="checkbox"/>	<input type="checkbox"/>
Stockpiles were not noted on maps but are discussed in the text.			
9.	Revegetation	<input checked="" type="checkbox"/>	<input type="checkbox"/>
Topsoil areas were observed and appeared to be in good condition with vegetation growing on them.

Topsoil pile in the background.

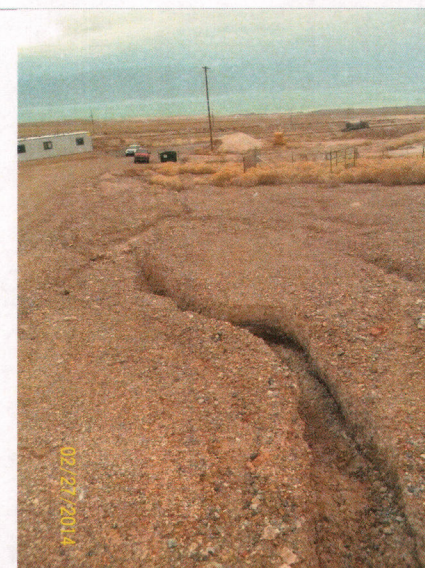
Erosion was noted along the access road.

2.	Public Safety (shafts, adits, trash, signs, highwalls)	<input type="checkbox"/>	<input type="checkbox"/>
3.	Protection of Drainages/Erosion Control	<input checked="" type="checkbox"/>	<input type="checkbox"/>
Erosion was noted on the main access road. Discussed blading a ditch along the road to better control runoff.
